2001 & LATER HYUNDAI

CODE P0500/501; LOSS OF VSS SIGNAL DIAGNOSIS

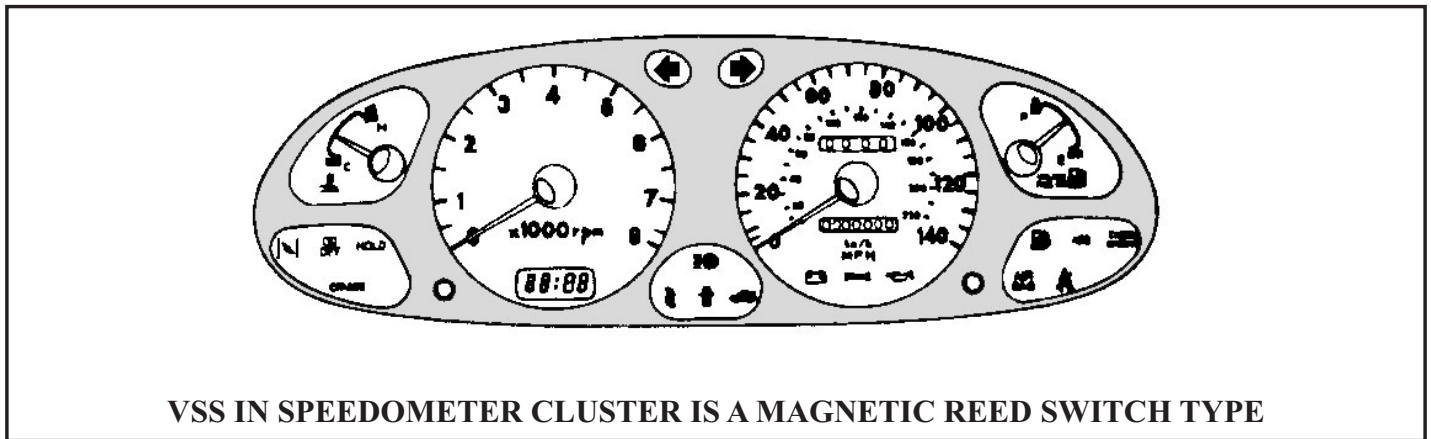
Figure 1

- (1) It could be located in the speedometer cluster, (**ACCENT ONLY**), this is a Magnetic Reed Switch type that requires the use of a speedometer cable. (See Figure 1)
- (2) It could be located in the transmission over the final drive and is gear driven, this is a Hall Effect type. (See Figure 2)
- (3) It could be the **RIGHT FRONT WHEEL SPEED SENSOR (RF-WSS)**, which is an AC Voltage Pulse Generator. (See Figure 3)

| <i>Reed Switch VSS (Speedometer Mounted).....</i> | <i>94216-33010</i> |

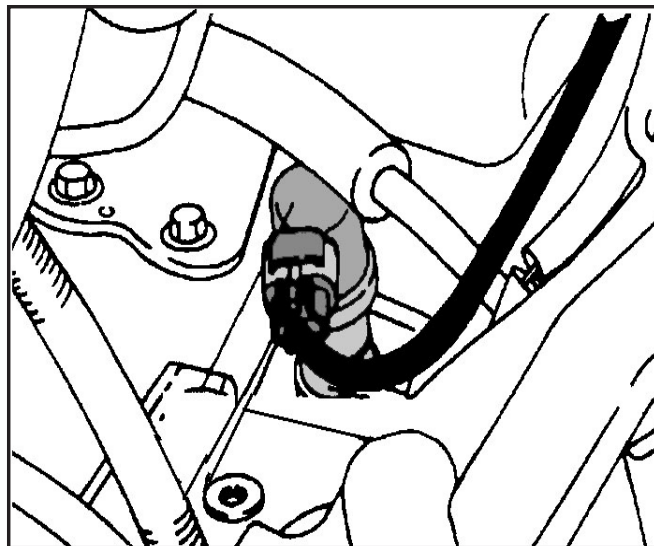
Figure 2

VSS IN TRANSMISSION IS A GEAR DRIVEN HALL EFFECT TYPE

| <i>Hall Effect VSS, Gear Driven (3 Wire) (Transmission Mounted).....</i> | <i>46517-39500</i> |

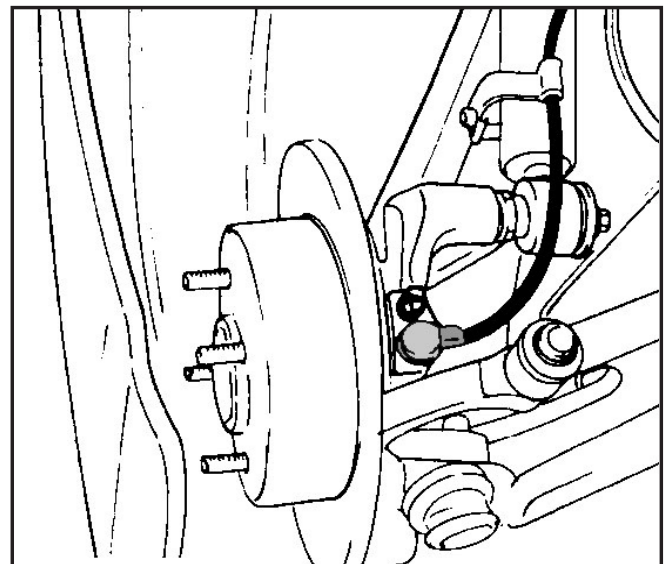
Figure 3

The Right Front Wheel Speed Sensor (RF-WSS), in some Hyundai models is used to determine if the vehicle is going over rough road. If the ECM determines that the vehicle is going over rough road, based on the roughness of the signal coming from the RF-WSS, the misfire diagnosis will be suspended until the driving conditions have changed. All Hyundai models with ABS use the RF-WSS to determine rough road conditions.

RF-WSS ON THE RIGHT FRONT WHEEL HUB IS AN AC VOLTAGE PULSE GENERATOR

| <i>Right Front Wheel Speed Sensor.....</i> | <i>95670-2D100</i> |
