JEEP WITH 2.5 OR 4.0 LITER ENGINES & AW4 TRANSMISSION

TPS CODE P0123 WILL NOT CLEAR

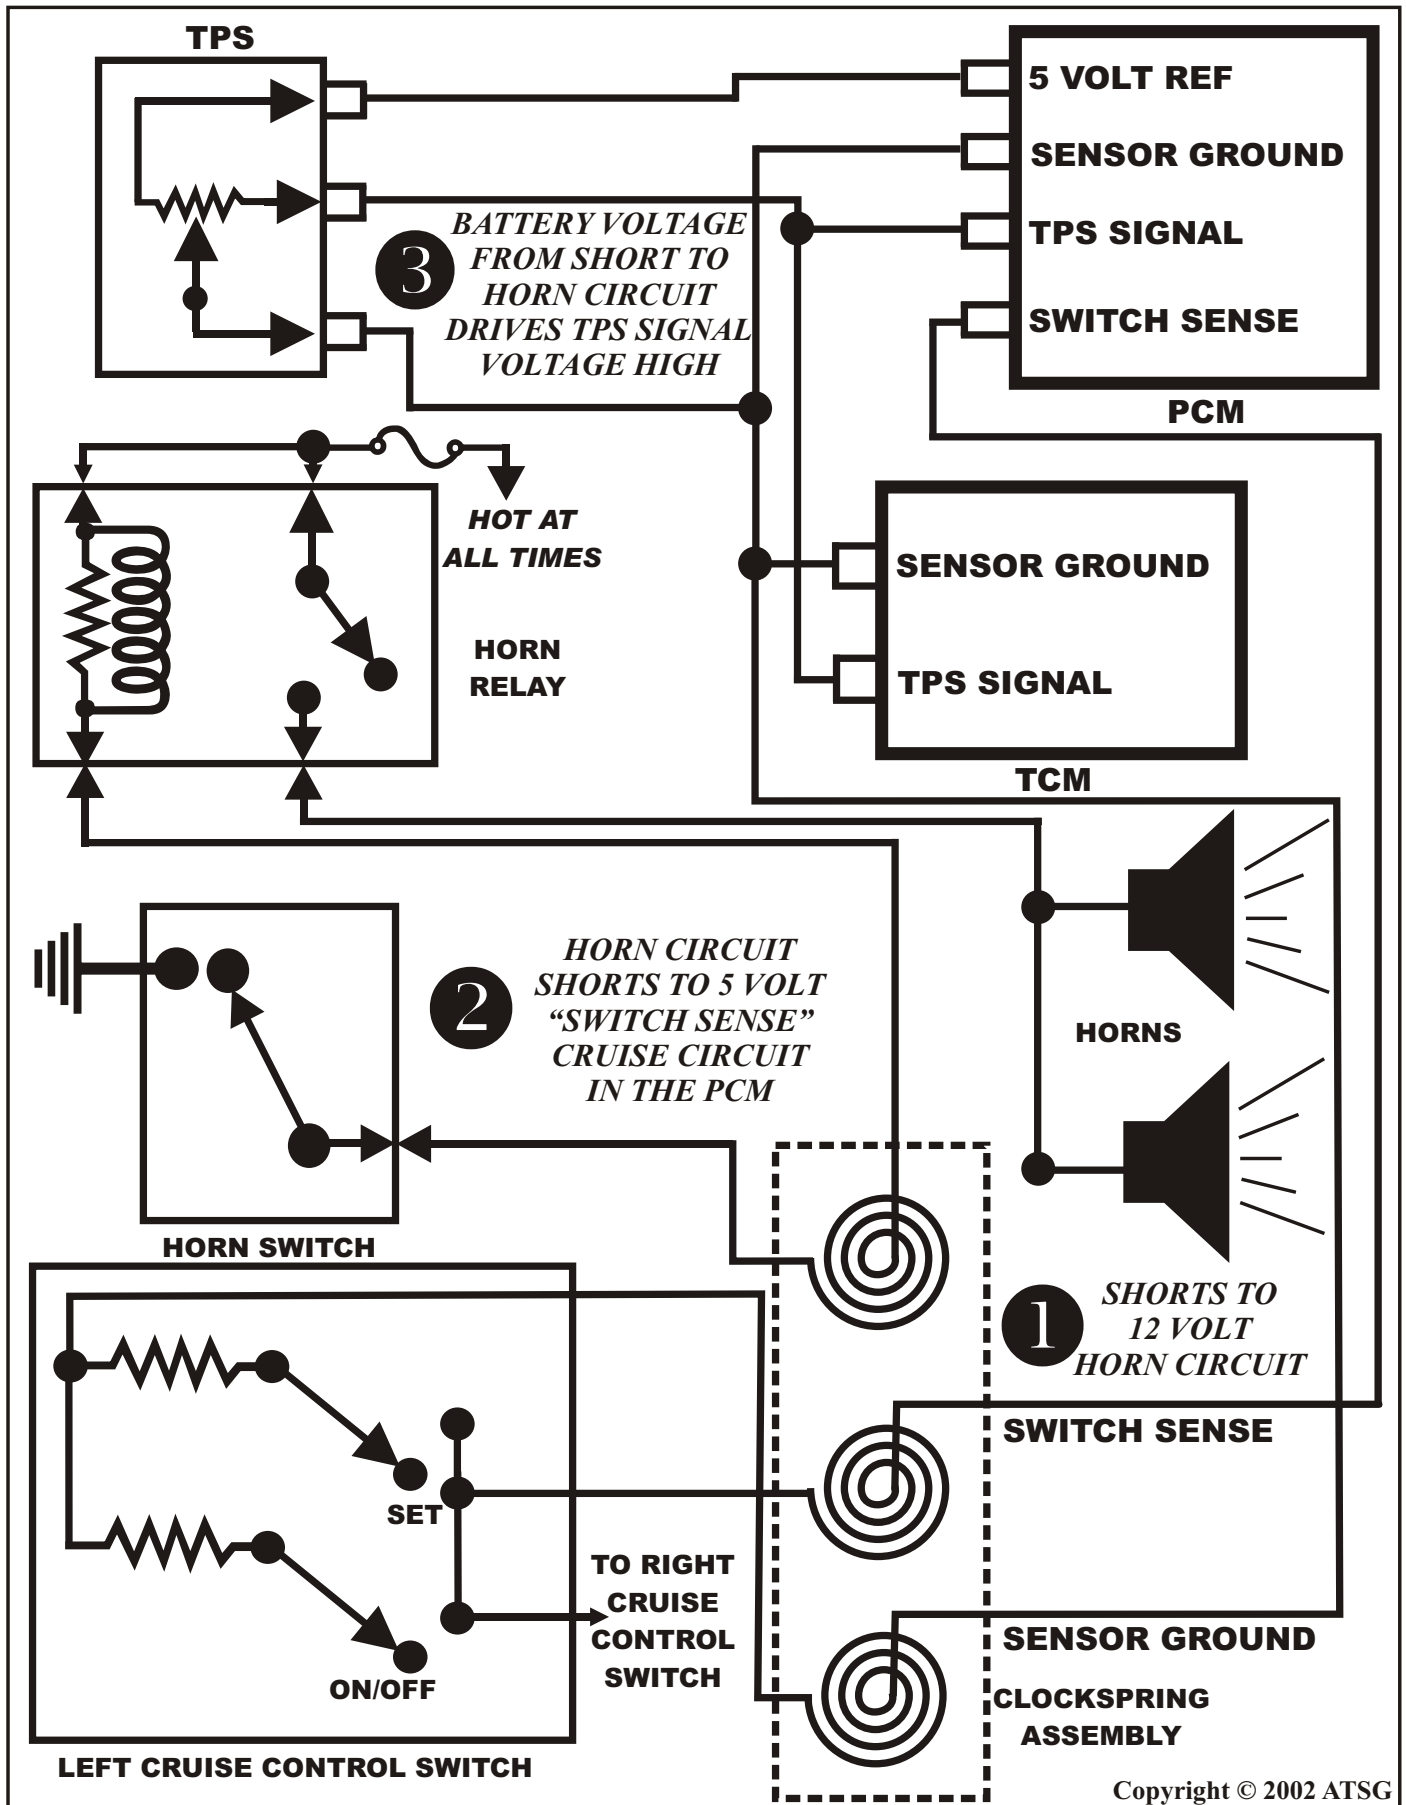
Figure 1
Automatic Transmission Service Group

- CAUSE:** The Switch Sense circuit in the Clockspring in the steering wheel hub has shorted to battery voltage from the horn button circuit. When the Switch Sense Circuit shorts to the 12 volt HORN circuit the TPS signal voltage is driven high and remains there as shown in Figure 1. This is because the 5 volt reference voltage used by the Cruise "Switch Sense" circuit and the TPS are shared inside the PCM.

- CORRECTION:** Replace the Clockspring assembly. Once the Clockspring has been replaced, be sure to check the sensor 5volt reference voltage at the PCM to insure that circuit has not been damaged by the short to power. Also check the TPS signal range to insure the TPS has not been fried.
