2000 & LATER DODGE TRUCKS & VANS

INTERNAL LINKAGE AND SAFETY NEUTRAL SWITCH CHANGES

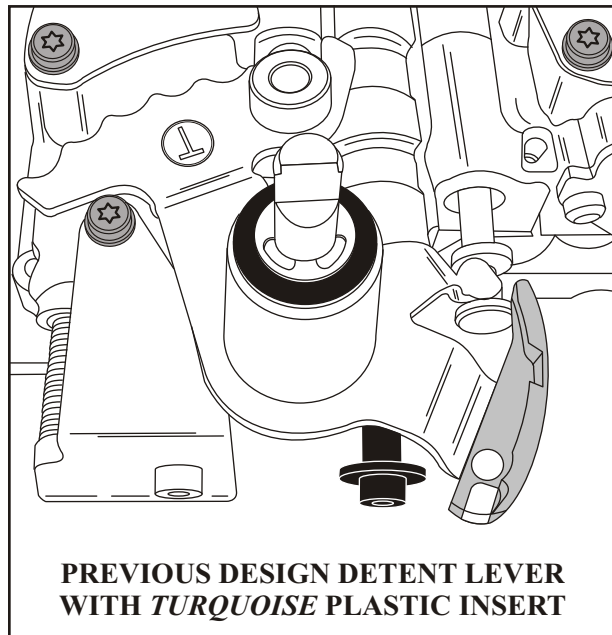
Figure 1

CAUSE: The safety neutral switch and the valve body detent lever changed for the 2000 model year. The switch is longer and the detent lever dimensionally changed to accommodate the new switch. Figures 1 and 2 show the dimensional differences between the previous and current design detent levers. Figures 3 and 4 illustrate the correct and incorrect assembly using the short switch. Figure 5 shows the correct assembly using the long switch.

CORRECTION: The detent lever with the **red** plastic insert goes with the **long** safety neutral switch. The detent lever with the **turquoise** plastic insert goes with the **short** safety neutral switch.
