2000 & LATER ISUZU NPR; CHEVY FORWARD; GMC TILTMASER

TPS RELEARN PROCEDURE

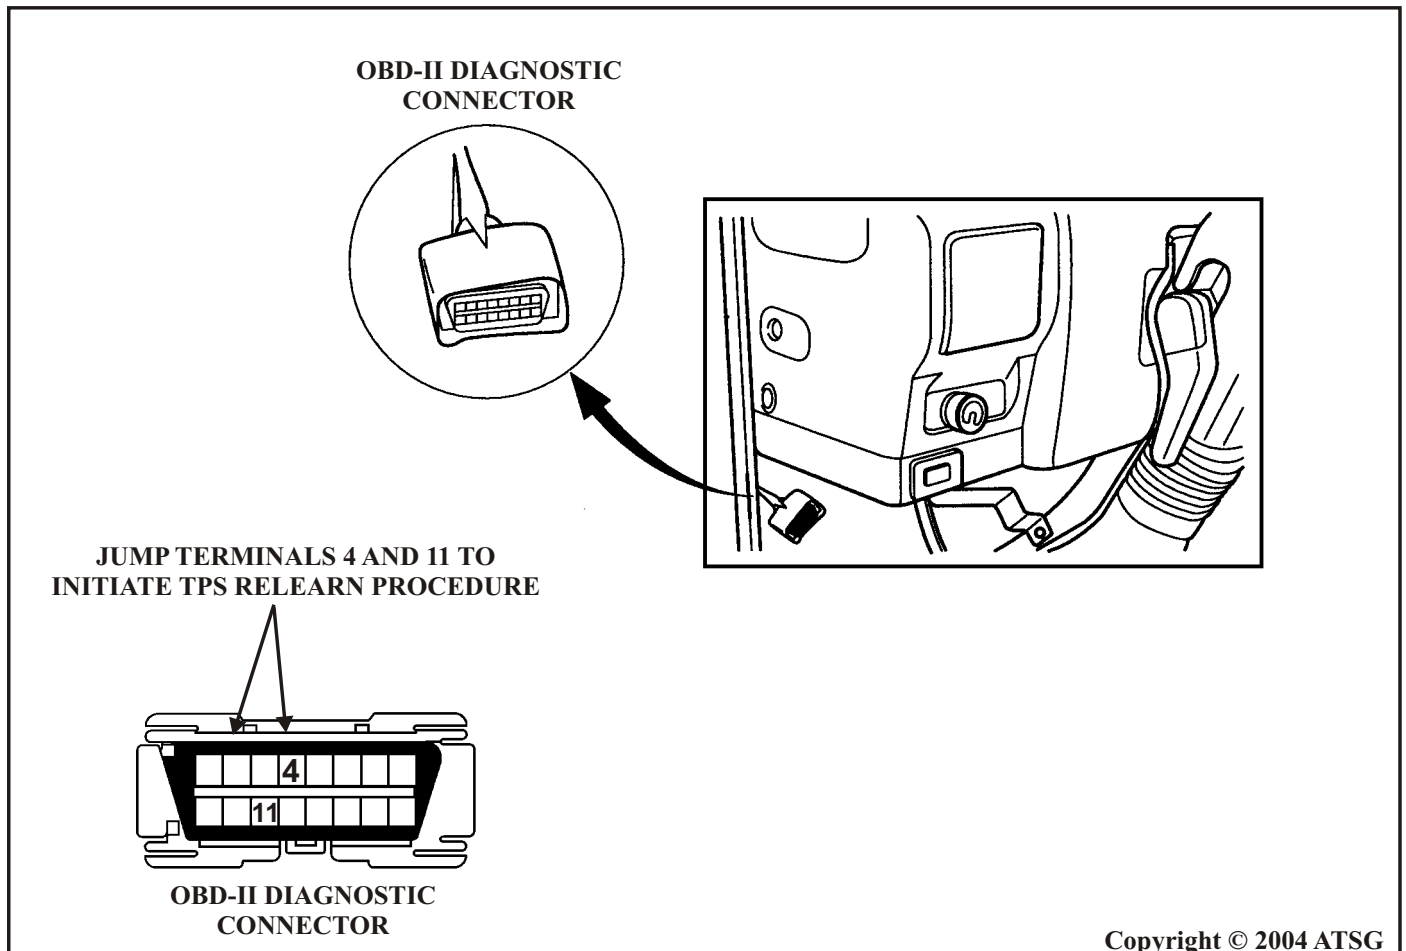
Figure 1

- 1. Turn the starter switch to the "ON" position.*
- 2. Connect terminals 4 and 11 of the Data Link Connector as seen in Figure 1, the "Check Trans" lamp begins flashing at 0.4 second intervals.*
- 3. Place selector lever in the "P" range.*
