5R55W/S**WATER IN THE TRANSMISSION**

COMPLAINT: The vehicle begins to develop driveability complaints and after a preliminary check of the oil condition, evidence of water contamination is found to be present.

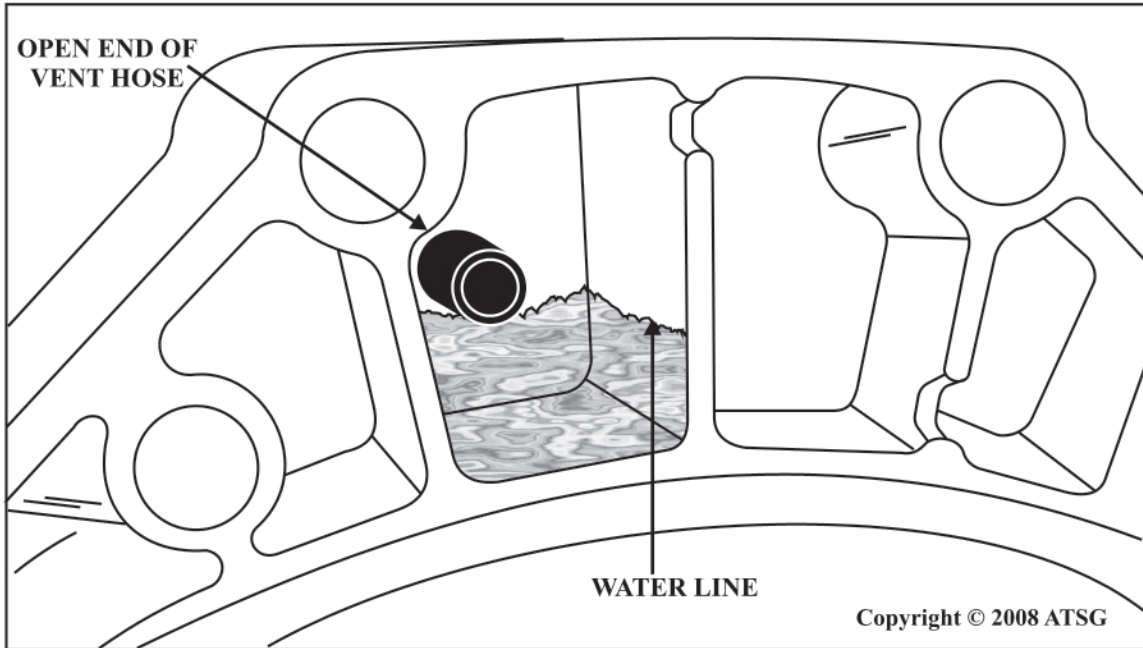
CAUSE: The transmission vent hose is routed to the upper front of the bellhousing where it exits into a casting pocket of the case.

Directly above this area is an AC pipe which is constantly dripping condensate onto the top front of the bellhousing. This water fills up the cavity in the case where the open end of the vent hose is located and water pours into the vent line which allows this water from the AC pipe to get into the transmission. In Figure 1 the water line can be seen in the vent hose pocket from the accumulation of water from the AC line.

CORRECTION: In order to prevent this from happening again, a good fix would be to cut the vent hose just behind the bellhousing and install a vent cap into the end of the hose and relocate it out of harms way as seen in Figures 3 and 4.

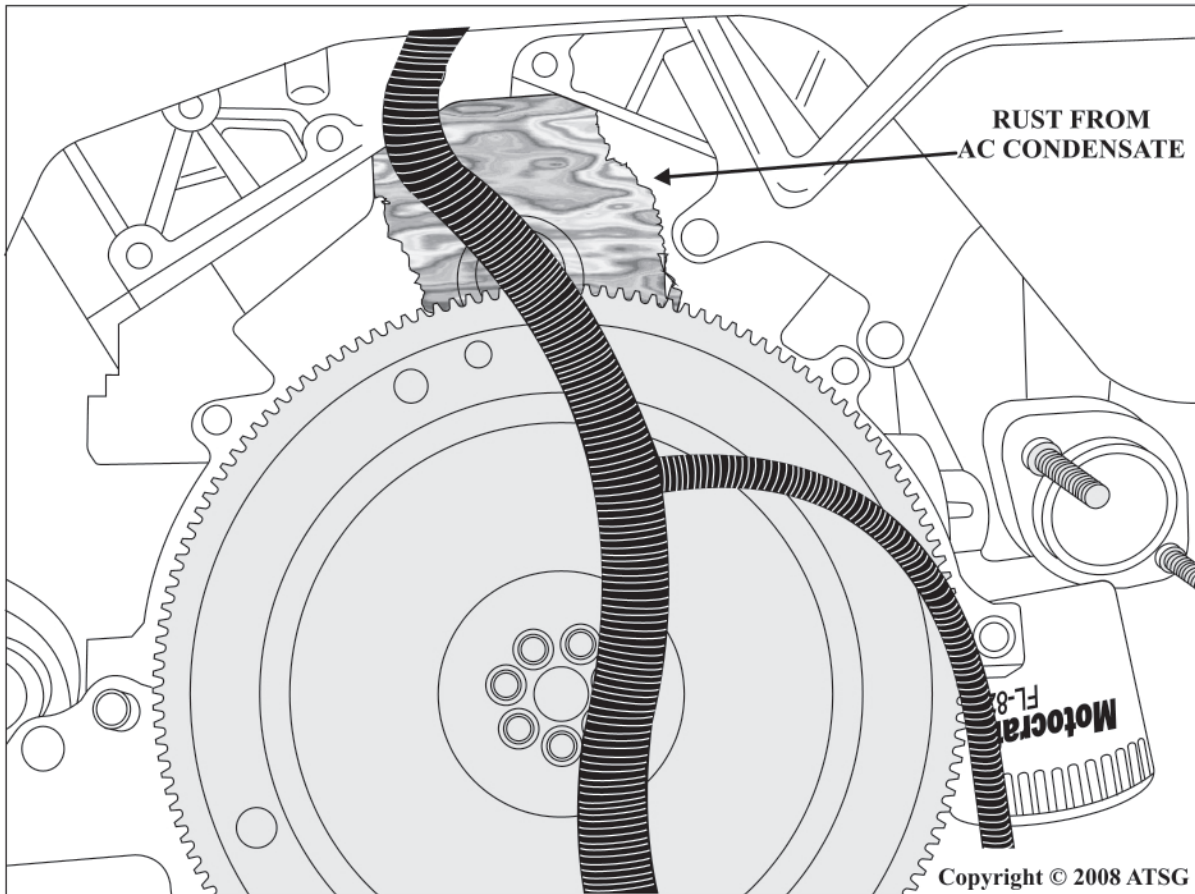
Figure 2

The water runs down the back of the engine turning all in it's path to rust as seen in Figure 2.
