FORD 5R110W TRANS RANGE SENSOR/ SPEED SENSOR FAULTS OR NO START

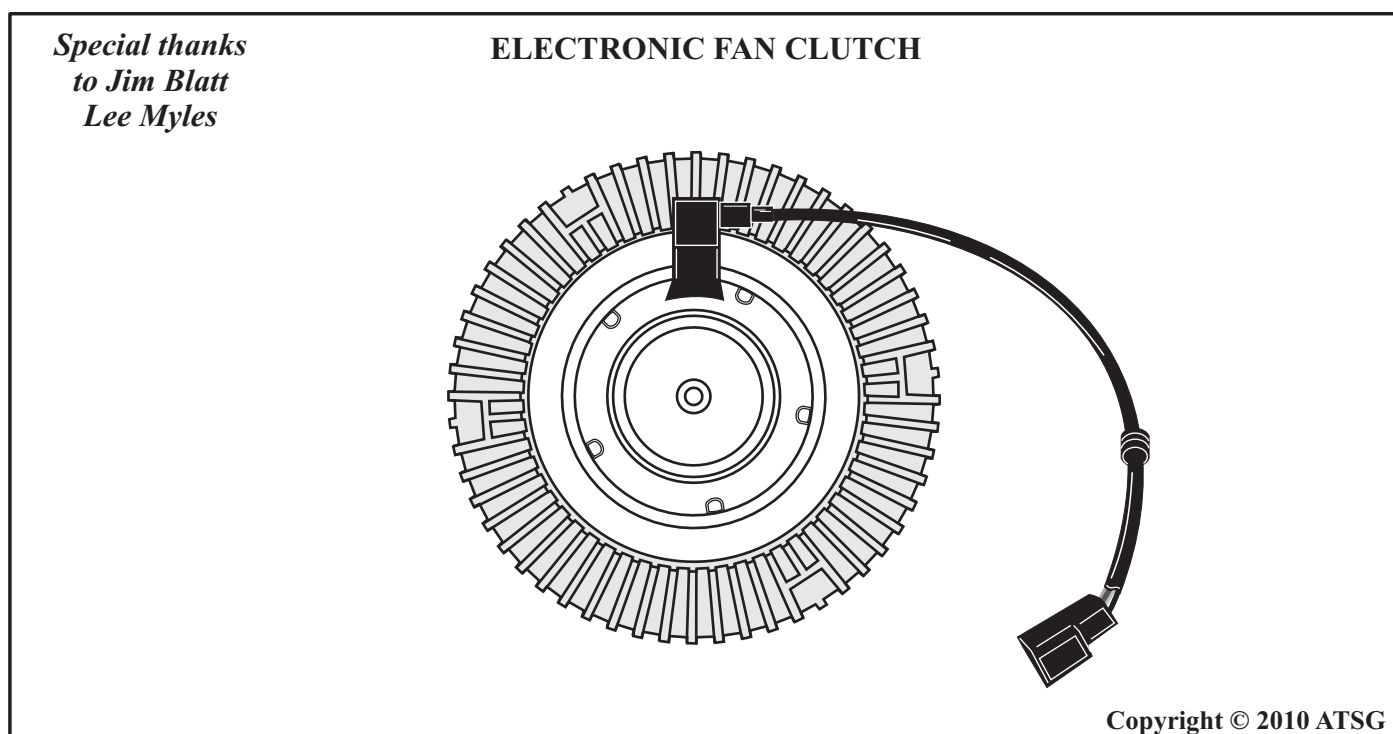
Figure 1

CAUSE: The cause may be a shorted Electronic Fan Clutch speed sensor, as shown in Figure 1, drawing down the Reference Voltage to the Transmission Range Sensor and the Turbine and Output sensors which are in-directly connected thru the PCM. This may cause these sensors to provide in-accurate information to the PCM, and of course a No Start situation if the Trans Range Sensor were not operating. Refer to Figure 2 for a connector identification for the PCM Connector "C" which is the connector that the Electronic Fan Clutch speed sensor is wired to, also shown in the partial schematic in Figure 3 . Terminal 46 is the Reference Voltage to the Speed Sensor which is housed inside of the Fan Clutch. Refer to Figure 5 and note that terminal 1 of the PCM connector "B" is the Reference Voltage for the Trans Range Sensor, Turbine, Intermediate and Output speed sensors, also shown in the partial schematic in Figure 6. These Circuits are connected internally in the PCM and if there is a short, it can affect the reference voltage to all.

CORRECTION: To correct this condition, locate the connector for the Electronic Fan Clutch, as shown in Figure 4 which is on the drivers side of the fan shroud, and simply dis-connect it. Clear all DTC's and re-drive the vehicle to verify if the codes reset, and or to see if the vehicle starts. If all is well, replace as necessary.
