DODGE/JEEP 42RLE MULTIPLE SOLENOID CIRCUIT AND PRESSURE SWITCH FAULTS

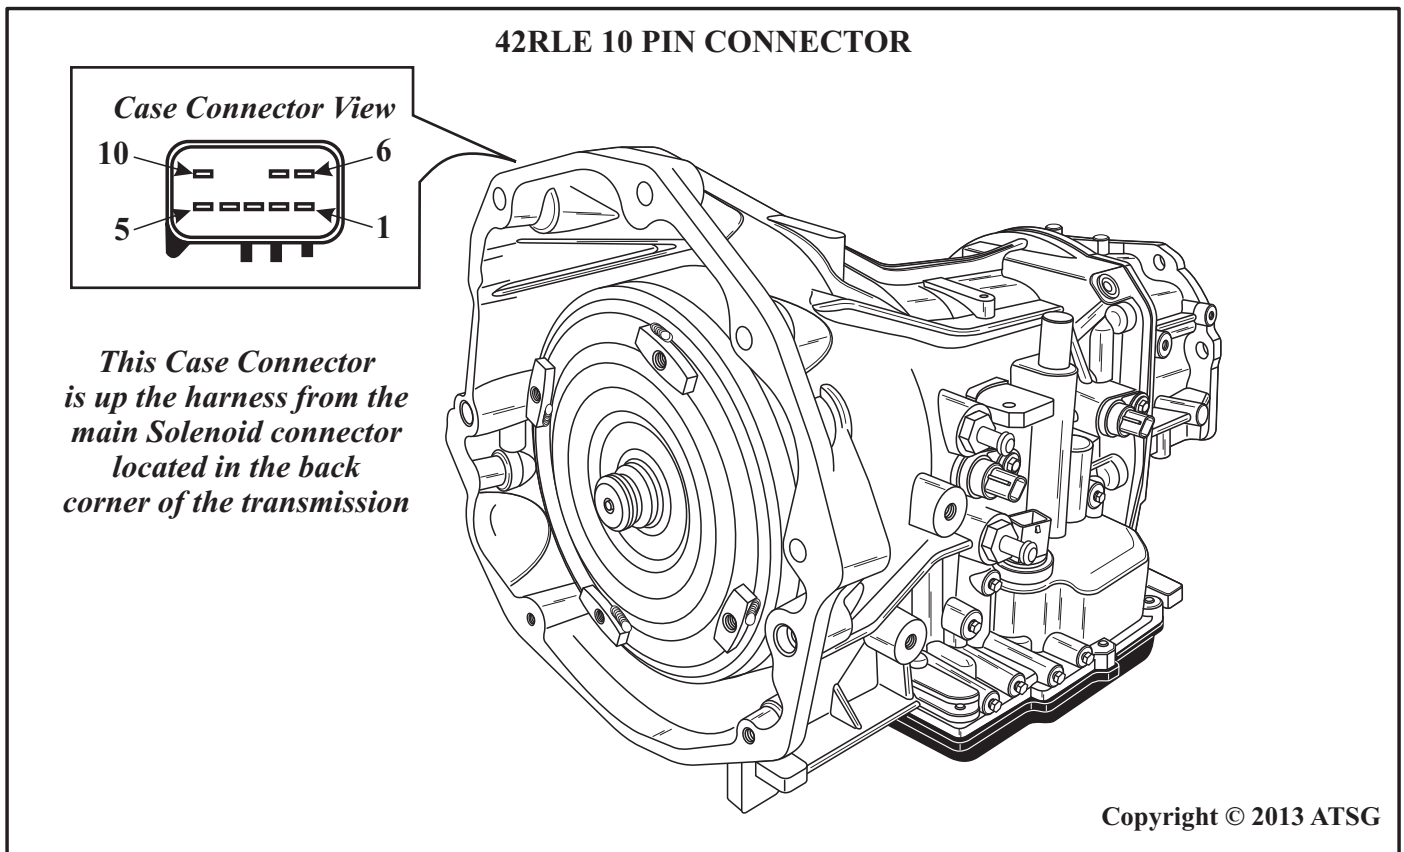
Figure 1
Automatic Transmission Service Group

CAUSE: The cause may be, moisture in the 10 pin solenoid harness connector as shown in Figure 1. This moisture can cause corrosion in the terminals in the case connector and the harness connector. Another cause may be a wiring problem between the TCM/PCM and the transmission harness connector. Note: 04-05 model Liberty have had harness problems between the TCM/PCM, with wire chaffing.

CORRECTION: To correct this complaint, locate the 10 pin connector, male and female connectors as shown in Figures 1 and 2. Inspect them for corrosion. If there has been moisture/corrosion, install the updated pig-tail as shown in service information. If the corrosion has affected the male terminals in the solenoid pack, it will need to be replaced as well. If the connectors are free from corrosion, refer to Figures 3 and 4 for the appropriate terminal identification for the TCM/PCM and verify harness integrity to the 10 pin connector, replace wiring as needed.
