**CHRYSLER 62TE
SEVERE 2-3 BIND OR SEVERE 5-6 BIND**

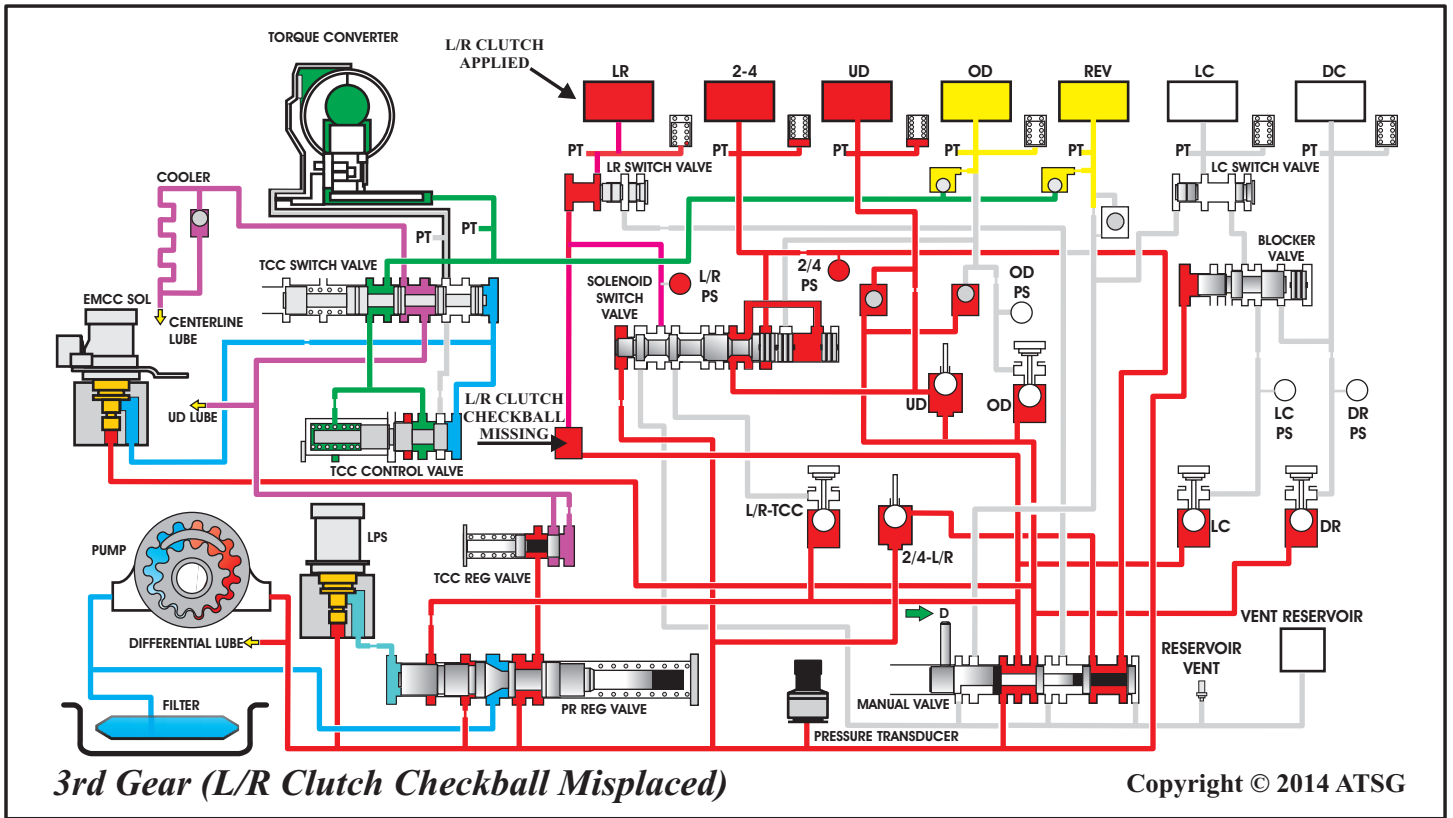
Figure 7

- (1) The rebuild technician mistakenly placed the Low/Reverse Clutch checkball in the Underdrive Clutch location, Figure 3. Since the Low/Reverse Clutch is applied in first and second gear, and must release for a shift into third gear as seen in the clutch application chart in Figure 4, the missing Low/Reverse Clutch checkball caused the Low/Reverse Clutch to remain ON resulting in a severe bind-up on the 2-3 shift as shown in the hydraulic schematics in Figures 5, 6 and 7.

- (1) Make certain that the Low/Reverse Clutch checkball is always in its proper location.
- (2) Check the separator plate to see if the Underdrive Clutch checkball is or is not required.

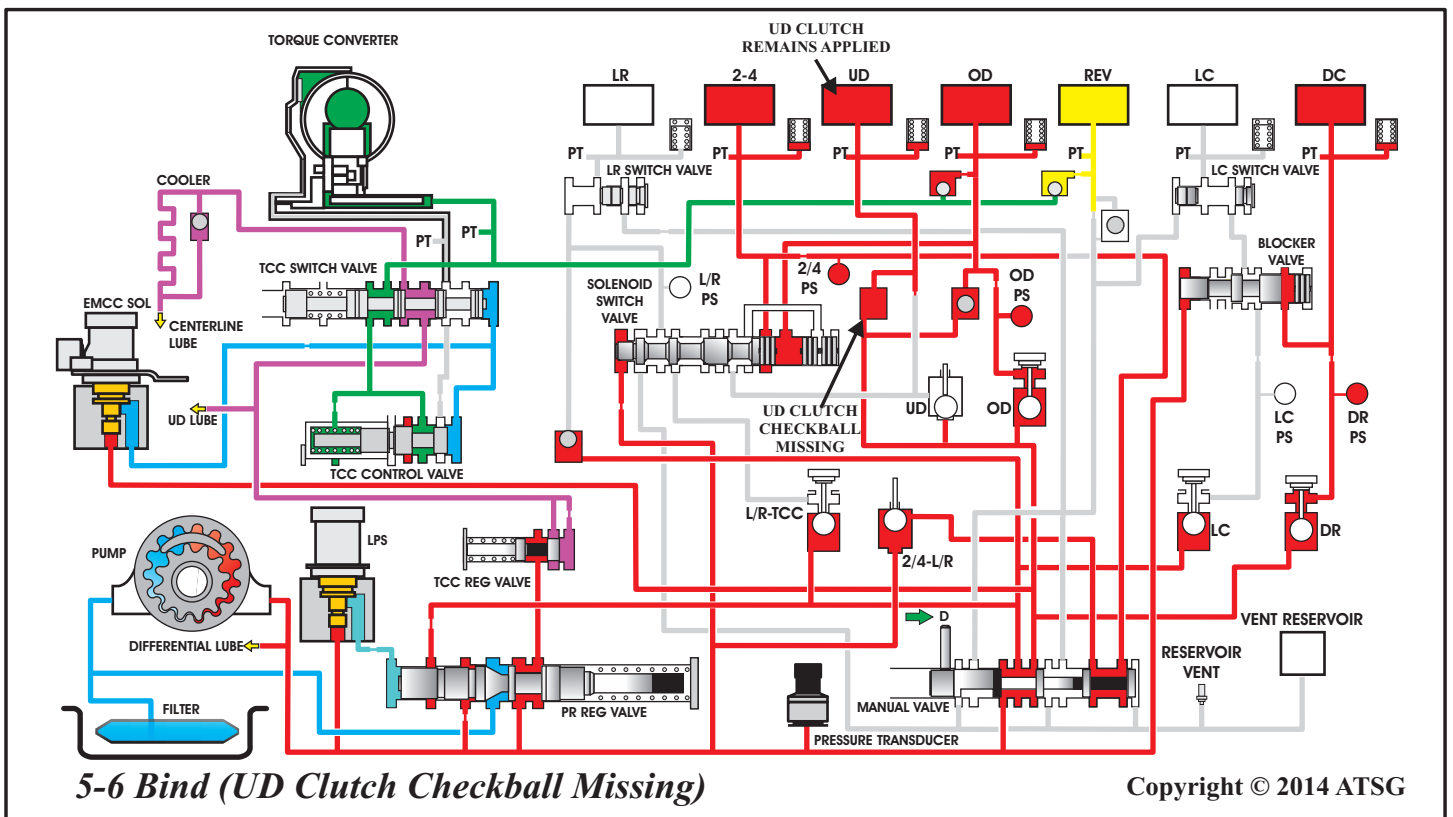
Figure 8

- (2) Certain models require a checkball in the Underdrive Clutch location (approximately 2010 and Later) and certain models do not. Models that have a hole in the separator plate over the Underdrive Clutch checkball pocket will require a checkball. Models with no hole in that location will not require a checkball, Figure 1. Refer to Figure 2 for correct checkball locations. The separator plate without the hole can be used in earlier models and the checkball can be omitted. The separator plate with the hole CANNOT be used in the later models without the checkball, this will result in a harsh application of the Underdrive Clutch and a sever 5-6 bind (Figure 8).

It is suggested to be in the habit of installing all 4 balls regardless of the plate to avoid the chance of having a sever 5-6 bind.
