**ALLISON 1000/2000 SERIES****NO FORWARD MOVEMENT - TRANSMISSION OVERTEMP**

COMPLAINT: A truck with an Allison 1000/2000 Series Transmission may have complaints of the transmission overheating and may be accompanied by a no forward movement condition, reverse operates normally.

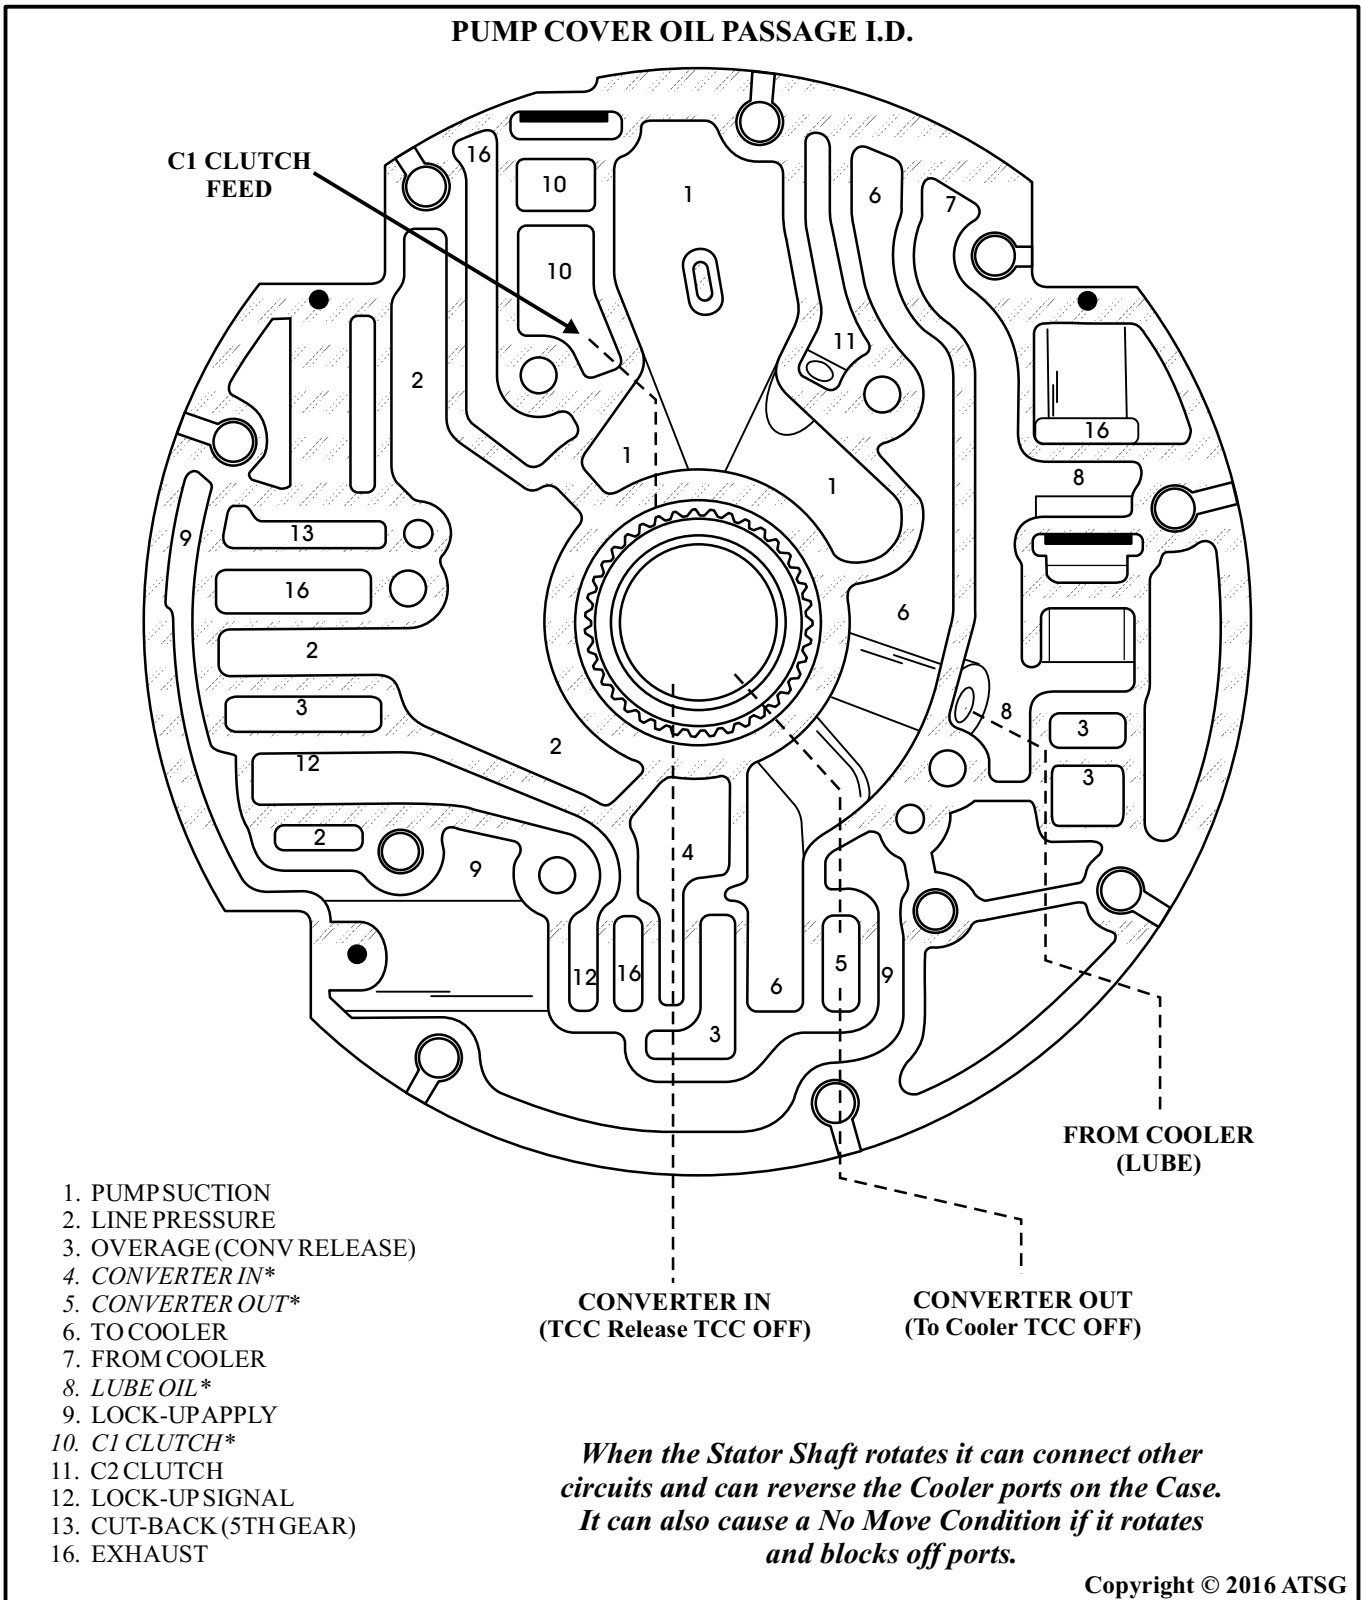
Figure 1
Automatic Transmission Service Group

CAUSE: The Ground Sleeve (Stator Shaft) has rotated out of position due to stripped threads in the pump cover. This rotation can connect the "Cooler In" circuit to the "Cooler Out" circuit thereby reverse cooler flow. The shaft rotation can also mis-align the C1 Clutch feed passage in the pump cover which will prevent the clutch from applying, Refer to Figure 1.
