VOLKSWAGEN / AUDI UNCONTROLLABLE HARSH 1-2 UPSHIFT

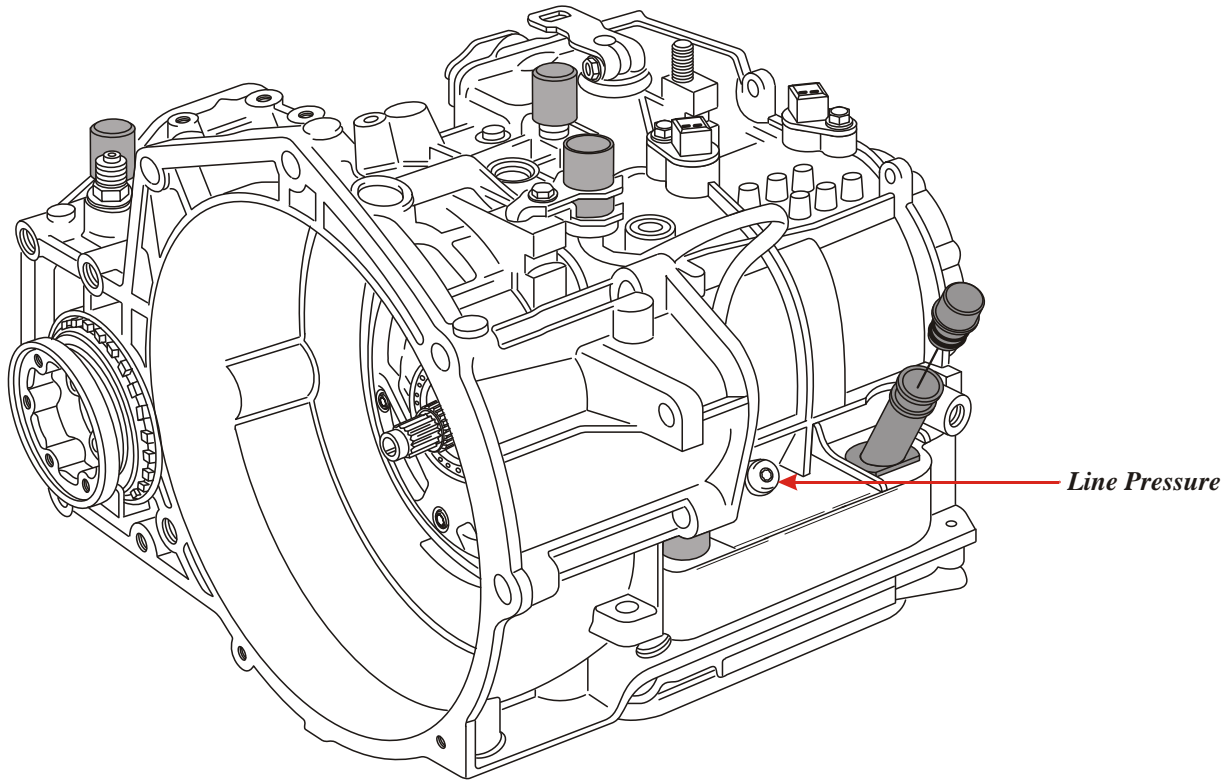
Figure 1

LINE PRESSURE CHECK

***LINE PRESSURE SHOULD INDICATE 60psi. AT IDLE IN DRIVE
LINE PRESSURE WILL INCREASE TO BETWEEN 120-150psi. AND
SHOULD CUT BACK TO 65-75 ON EACH SHIFT***

1. Connect a pressure gage to the line pressure port as shown in Figure 1. Line pressure should indicate 60 psi. in the Drive position at idle and should increase to 120-150 psi. at stall. Line pressure should cut back to between 65-75 psi. on each shift. If Line pressure does not cut back on each shift, or is at 120-150 psi. at all times, or is erratic on the gage, replace the EV6 solenoid and check the Boost Regulator and Main Regulator valve to ensure they are not stuck. Refer to Figure 2 for a description of how EV6 Solenoid operates.
2. Refer to Figure 5 and locate terminal 7 at harness connector. Back probe that terminal to verify that the computer is grounding EV5 during the 1-2 upshift. If the computer is not grounding that terminal, go to STEP A. If the Computer is grounding that terminal go to STEP B.

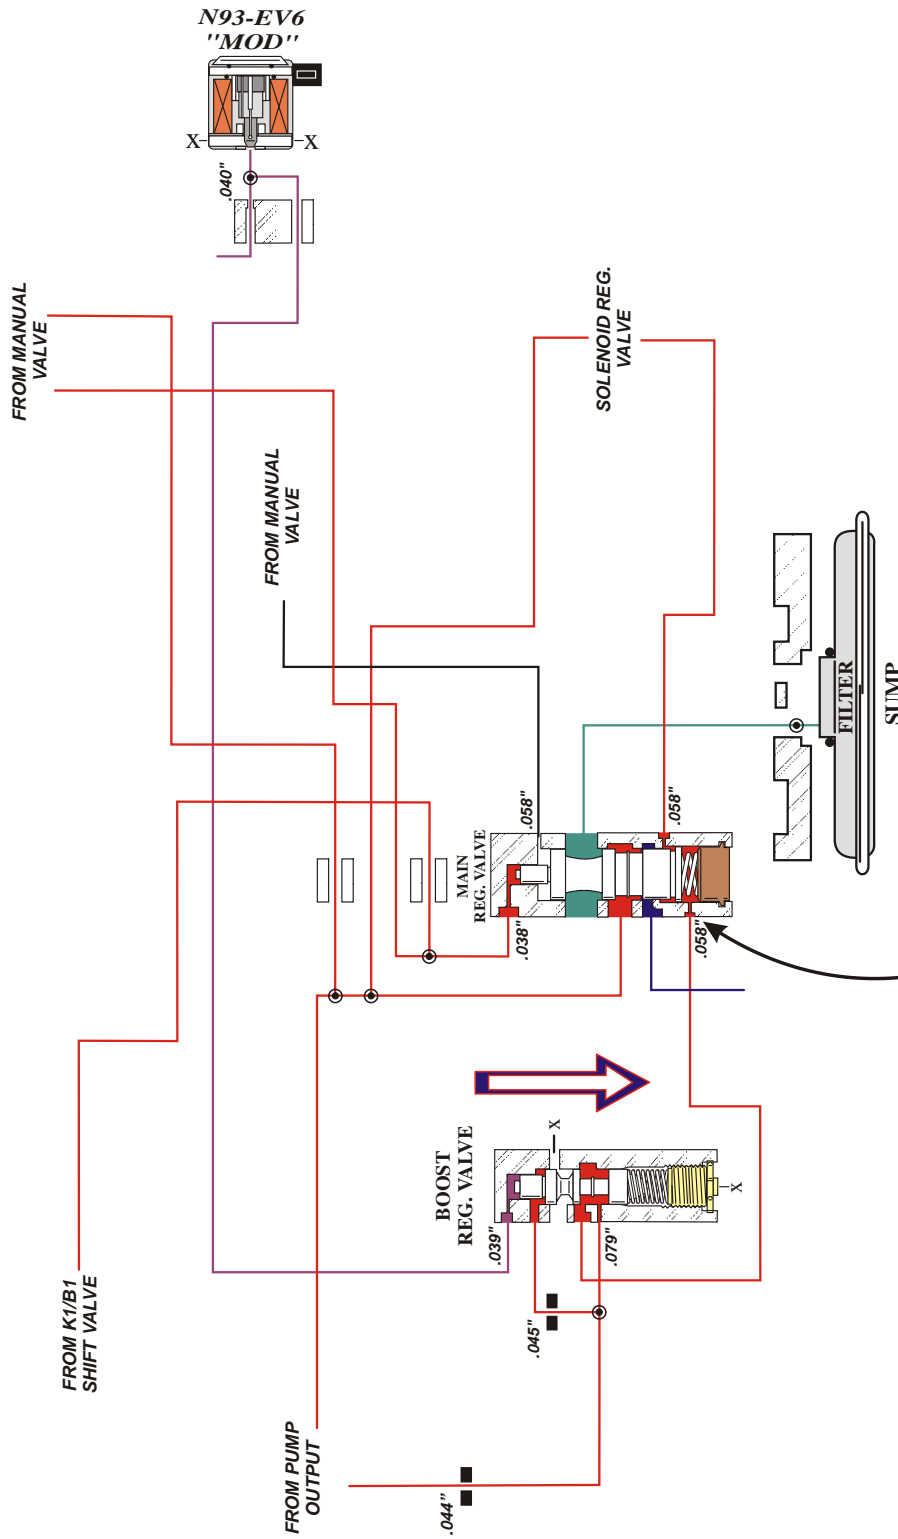
Figure 2
Automatic Transmission Service Group

"01M" N93-EV6 OPERATION

N93-EV6, WHEN MODULATING, STROKES THE BOOST REGULATOR VALVE AGAINST ITS SPRING, REDUCING THE AMOUNT OF BOOST PRESSURE ON THE SPRING SIDE OF THE MAIN REGULATOR VALVE.

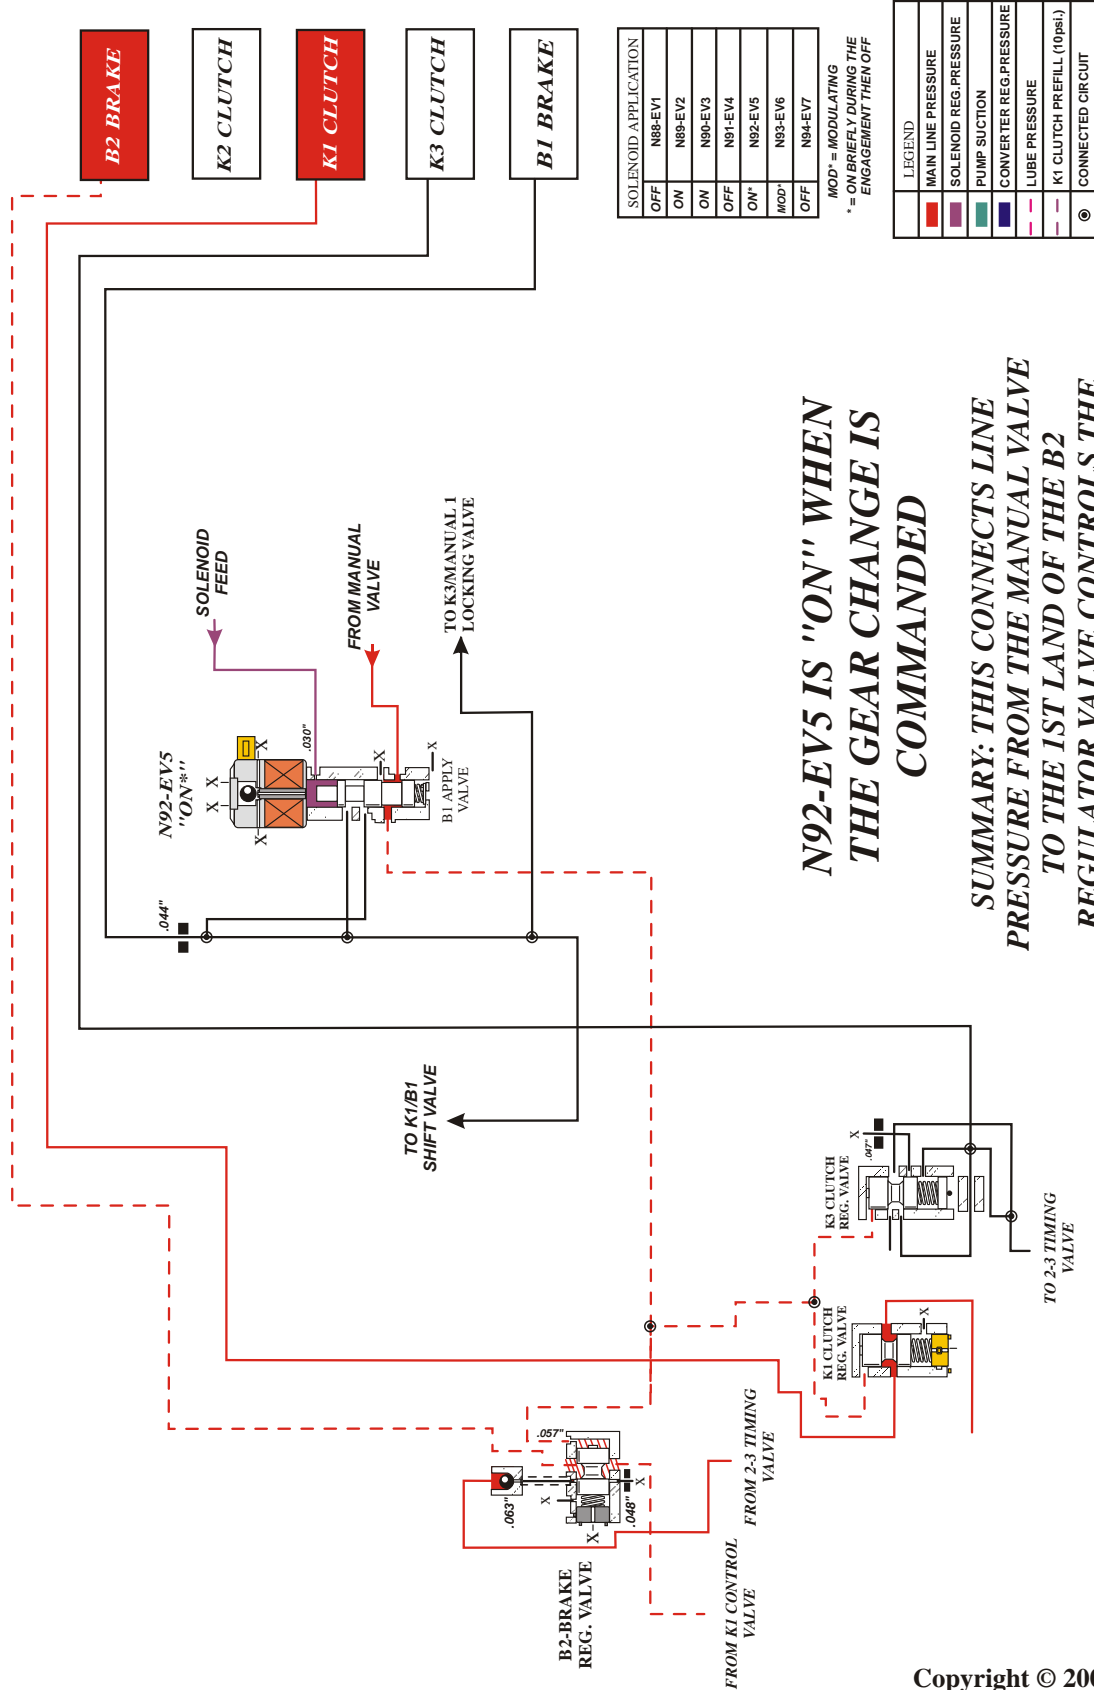
Figure 3
Automatic Transmission Service Group

"01M" OVERDRIVE RANGE 1st to 2nd GEAR TRANSITION

N92-EV5 IS "ON" WHEN THE GEAR CHANGE IS COMMANDED

SUMMARY: THIS CONNECTS LINE PRESSURE FROM THE MANUAL VALVE TO THE 1ST LAND OF THE B2 REGULATOR VALVE CONTROLS THE APPLY RATE OF THE B2 CLUTCH

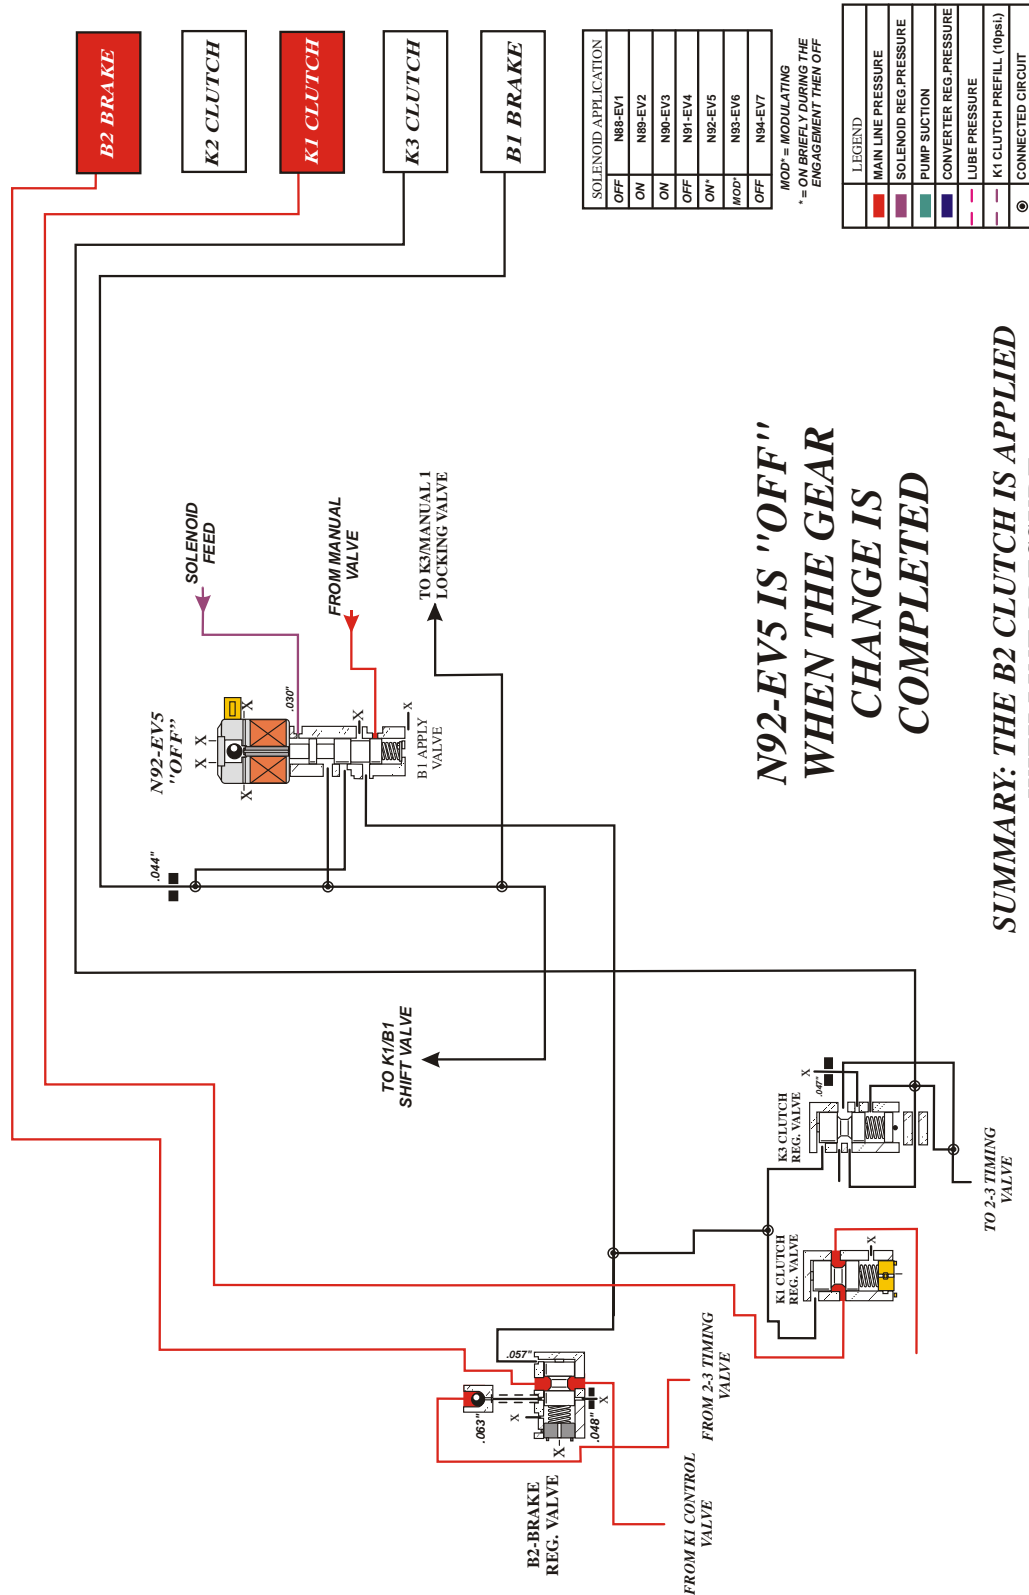
Figure 4
Automatic Transmission Service Group

"01M" OVERDRIVE RANGE 2nd GEAR APPLICATION

**N92-EV5 IS "OFF"
WHEN THE GEAR
CHANGE IS
COMPLETED**

**SUMMARY: THE B2 CLUTCH IS APPLIED
WITH LINE PRESSURE**

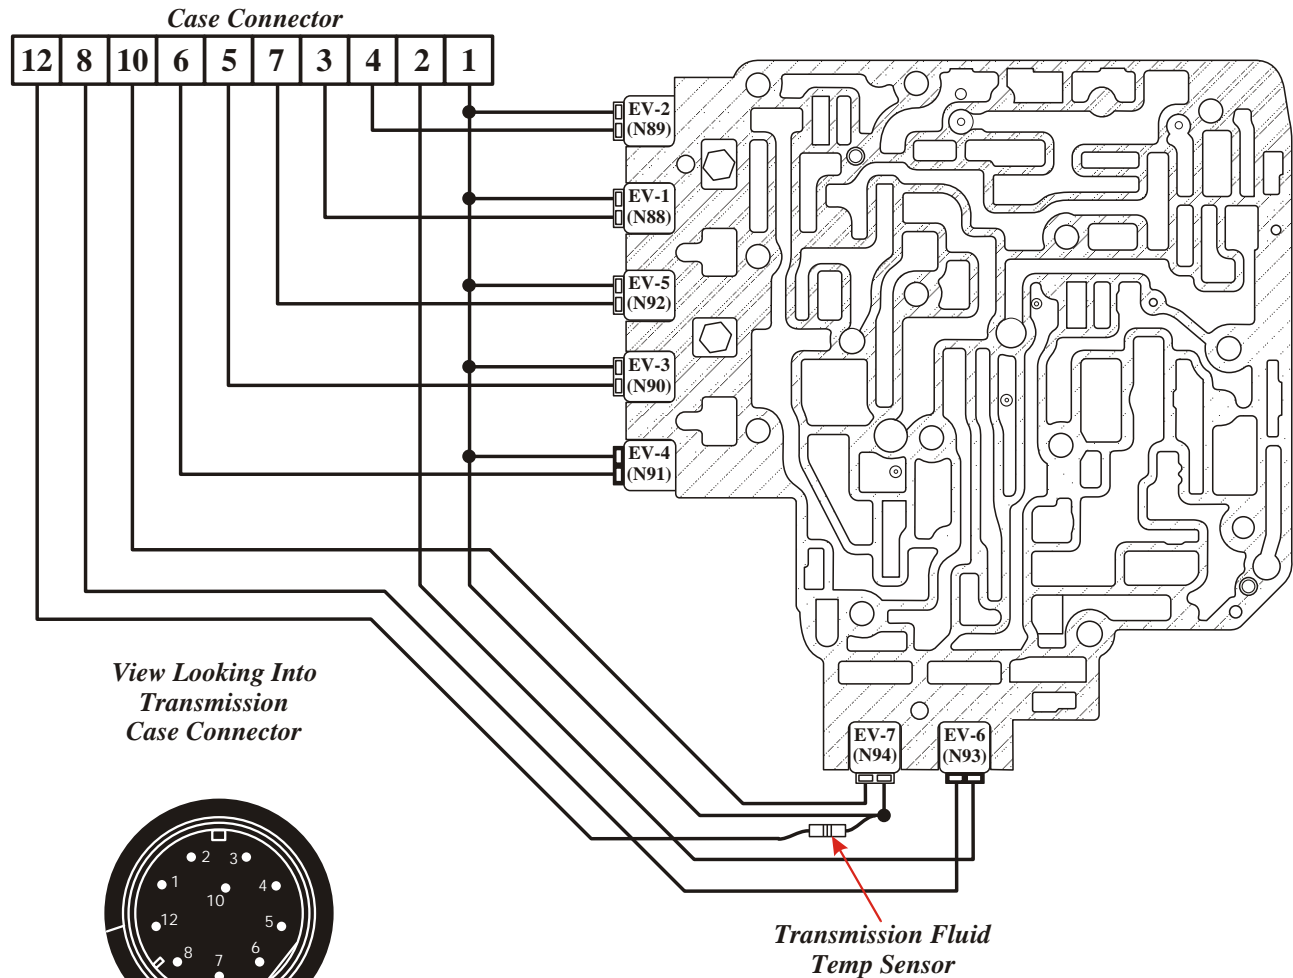
Figure 5
Automatic Transmission Service Group

CASE CONNECTOR PIN FUNCTIONS

***BACK PROBE
THIS TERMINAL***

STEP A. Connect a scan tool to the diagnostic connector and check to see if the TCM has set a trouble code 00266 (VAG) or a P0773 which are EV5 solenoid circuit faults. Repair the EV5 Solenoid circuit as needed. If the TCM has no trouble codes set and does not ground EV5 Solenoid during the 1-2 shift, the TCM may be faulty.

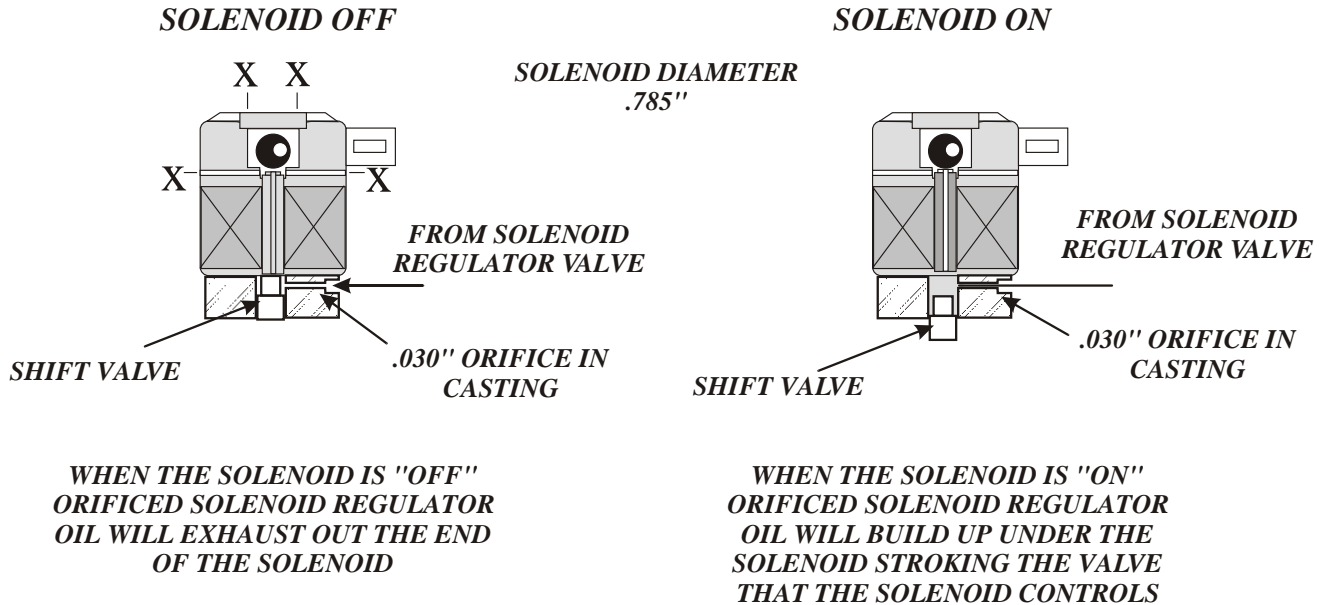
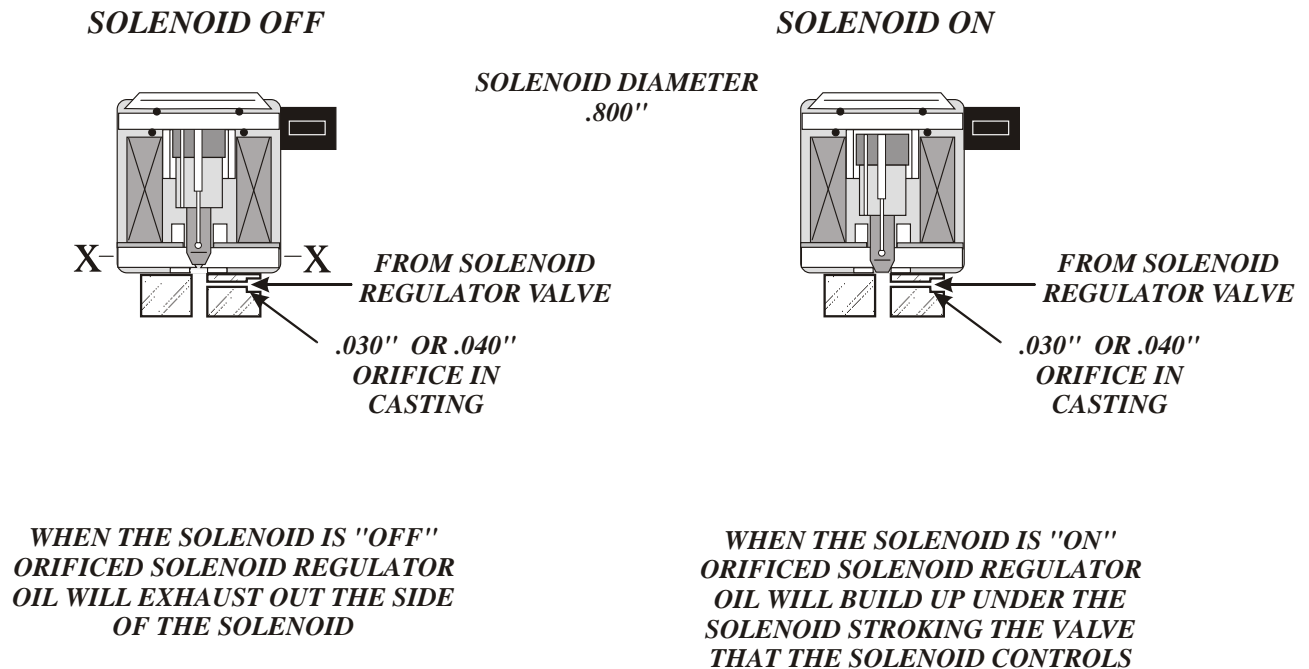
Figure 6

**EV1 (N88), EV2 (N89), EV3 (N90), EV5 (N92) AND EV7 (N94)
SOLENOID CHECK AND OPERATION**

**EV4 (N91) AND EV6 (N93)
SOLENOID CHECK AND OPERATION**

3. Remove EV5 Solenoid from its bore. Ensure that the B1 Apply valve, which is located below the solenoid, is not sticking in it's bore. Air check EV5 solenoid and ensure it's proper operation as shown in Figure 6. If EV5 Solenoid does not close consistently replace as needed.
